Hubble Space Telescope
High Speed Photometer
Orbital Verification Test Report

Space Science and Engineering Center
and
Space Astronomy Laboratory
University of Wisconsin
Madison, WI

November 1991

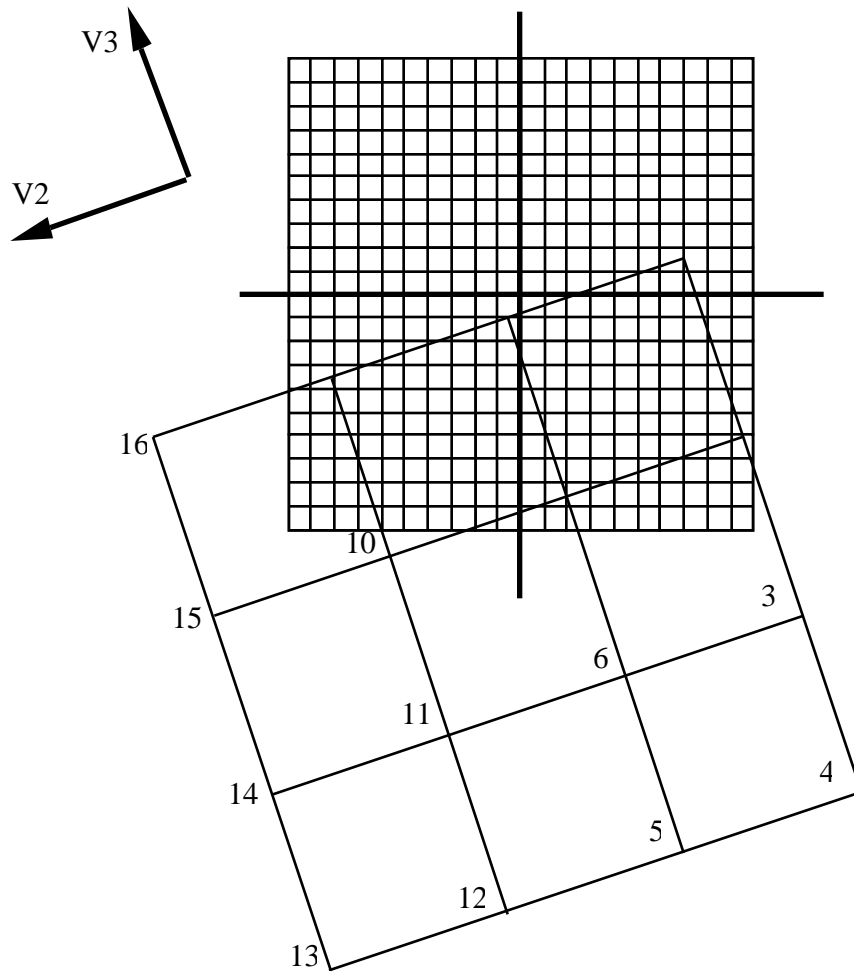
IDT 2 (UV1) 1503 Results

The chart above shows the position of the target star in the HSP 20x20 map of the finding aperture for each of the 16 positions of the HST step and dwell scan. The target was seen only in steps 1, 2, 7, 8, and 9.

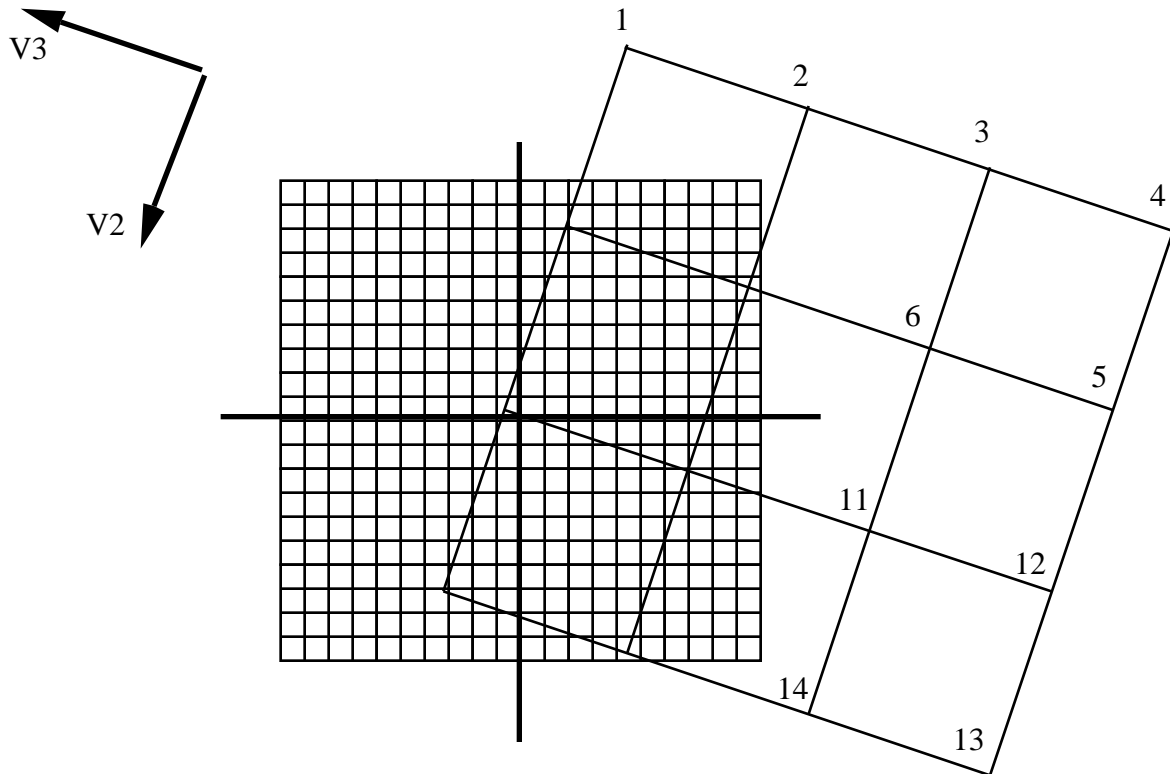
IDT 4 (UV2) 1503 Results

The above chart shows the position of the target star in the 20 x 20 map of the HSP finding aperture for each of the 16 points in the HST step and dwell scan. The target was seen only in steps 7, 8, 9, 10, 15, and 16.

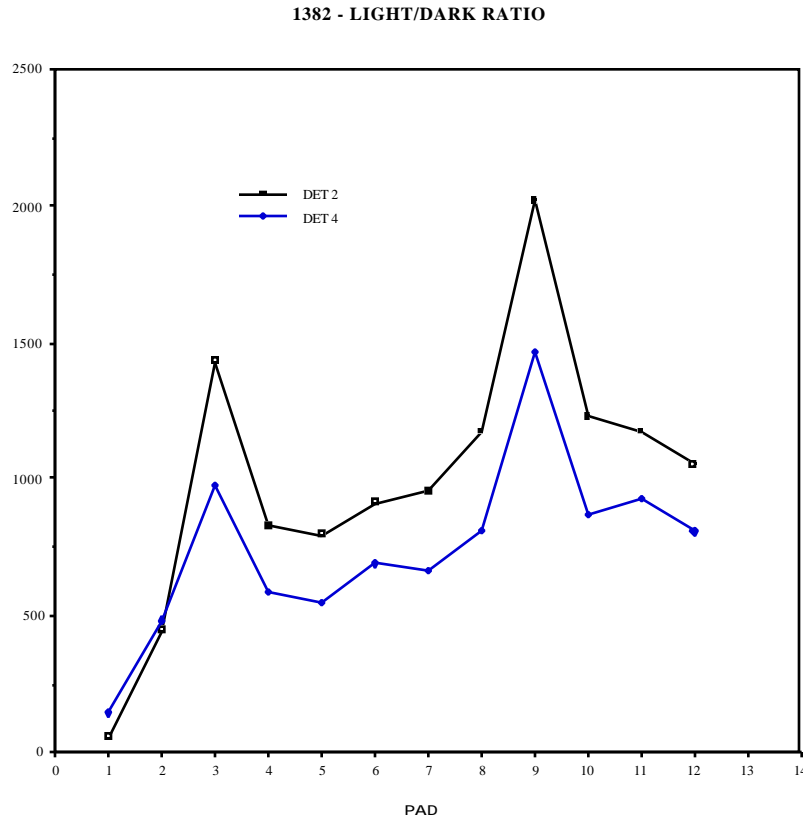
The purpose of this test was to determine the optimum PAD threshold by observing the bright earth at various threshold levels and plotting the curve of response as a function of threshold level. The unpredictably large variations in the brightness of the earth proved to be greater than differences between threshold levels and the resulting data (see chart below) were of little value beyond confirming that the prelaunch PAD default values were satisfactory.

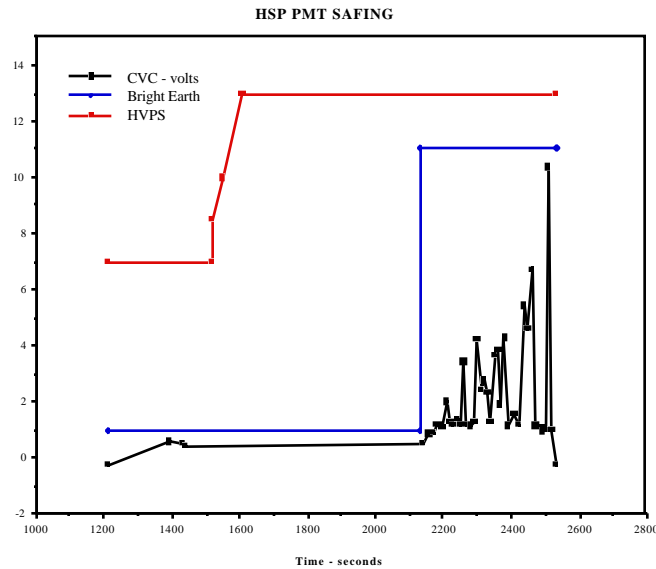
HSP 1379 PMT Detector Dark Count test started as scheduled on day 231 beginning at 01:22:25 GMT. At 90:231:01:42:10 UTC HSP entered SAFE MODE due to Bright Object Protection. Analysis of the near real time engineering data shows VCVAMP5 at 10.34 volts just before BOP was tripped indicating that the PMT had been pointed at a bright target. Looking at the PASS HST Occultation Schedule Report, the V1-axis was occulted by the bright Earth at the time of safing. Although HSP was not in a data collection mode at this time, the high voltage had been ramped to it's full operate level of 2184 v. Note that the V1-axis was not occulted by the bright Earth at the time the first data collection scheduled.

The PMT appears to have behaved nominally.
