WFPC2 Shutter Anomaly History and Status

7 December 2000

WFPC2 Shutter Anomaly - Stefano Casertano

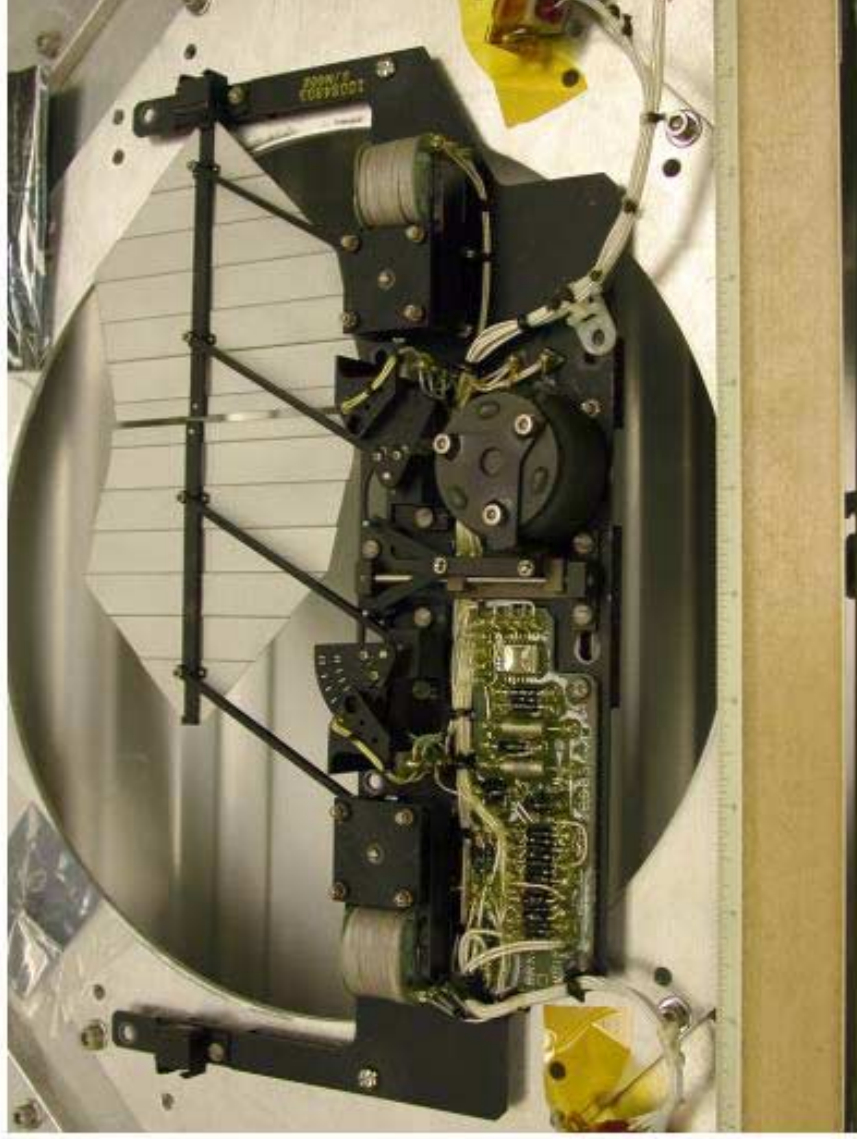
WF/PC shutter

- ◆ Primary anomaly most likely due to degradation in LED/sensor assembly combined with mechanical misalignment:
 - At start of exposure, microprocessor inquires about blade position

- LED turned on, sensor polled after 30 μs (light = blade open, no light = blade closed). Blade A sensor incorrectly reports no light, implying both blades closed. Error condition occurs, shutter open operation aborted; Blade A remains open, B closed

- Blade A sensor correctly reports light (blade open) after 200 μs , when the register value is stored in telemetry data - too late
 - If exposure < 180s (i.e., under microprocessor control), all shutter activity aborted. Shutter does not move, next exposure will also see anomaly

- If exposure > 180s (i.e., under AP-17 control), shutter close operation commanded. Blade A closes, pushes Blade B open. Shutter timing confirms slower blade motion

- ◆ **RAM patch developed to address the primary anomaly: extends LED on-time prior to sensor readout. Installed and verified November 8.**
- ◆ **Suite of WFPC2 test exposures to verify functioning and calibration of camera pre- and post-patch. All checks passed. Camera returned to science operations.**

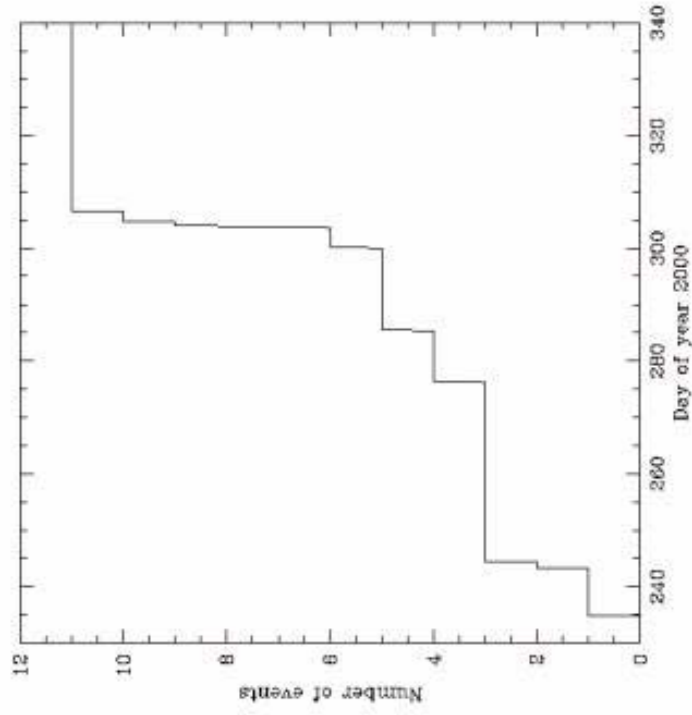
Cumulative Number of Shutter Anomalies

- ◆ 11 separate primary anomalies, August 21-November 1 (2417 exposures), of which 6 between October 26 and November 1 (79 exposures)
- ◆ 3 secondary anomalies: October 26, 29, November 1

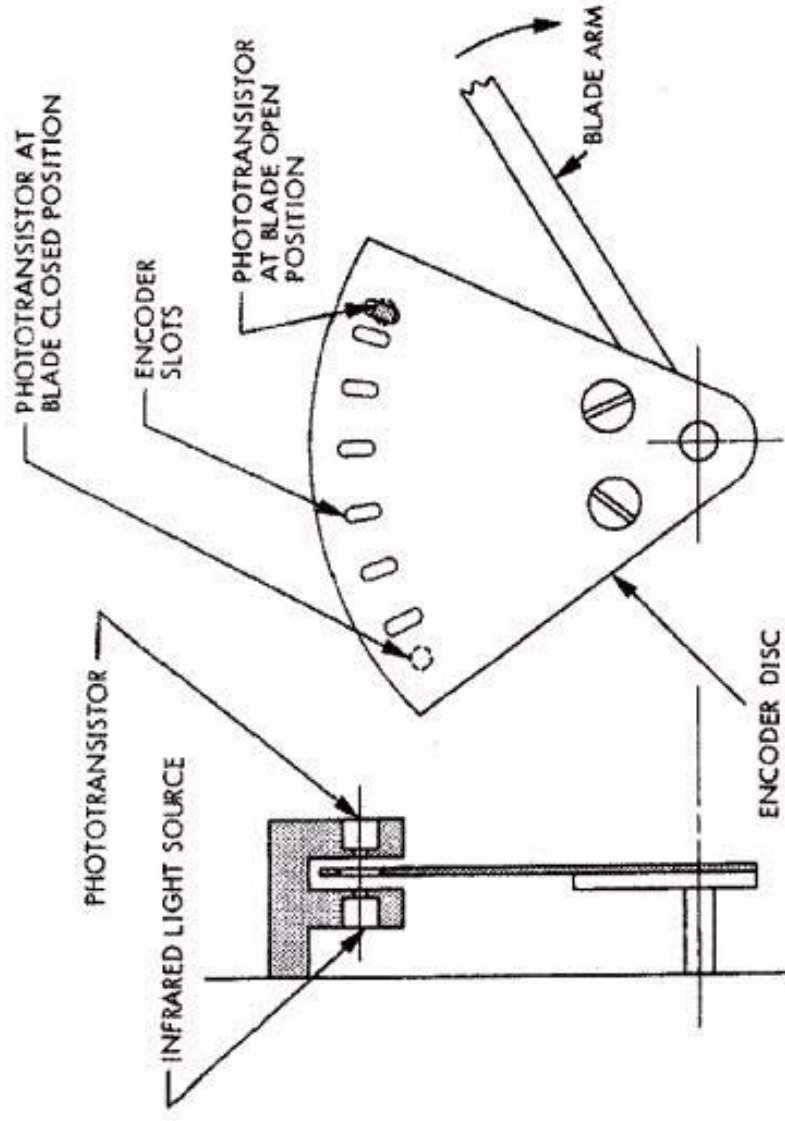
Encoder disc and follower arm

- ◆ **Mechanical tests:**
 - 0.7 deg misalignment could produce observed behavior
- ◆ **Radiation degradation:**
 - Some LEDs known to be proton-sensitive
 - Spare parts available for radiation testing (January-February 2001)
- ◆ **Secondary anomaly:**
 - Failure of "blade push" to properly open Blade A
 - After push, Blade A "bounces" open; shutter stays open at end of exposure
 - Shutter may or may not be closed at readout; if not, next exposure will start with shutter open
 - Behavior reproduced in ground testing
- ◆ **RAM patch (current fix):**
 - Turn on LED 10 ms before sensor is polled (sensor gives correct answer after 200 μ s)
 - Patch developed by Michelle Troeltzsch and Bobbie Woo; involves 14 new instructions, can be turned on and off with changes to 3 instructions
 - No expected impact on camera performance or operations
 - Completely successful so far

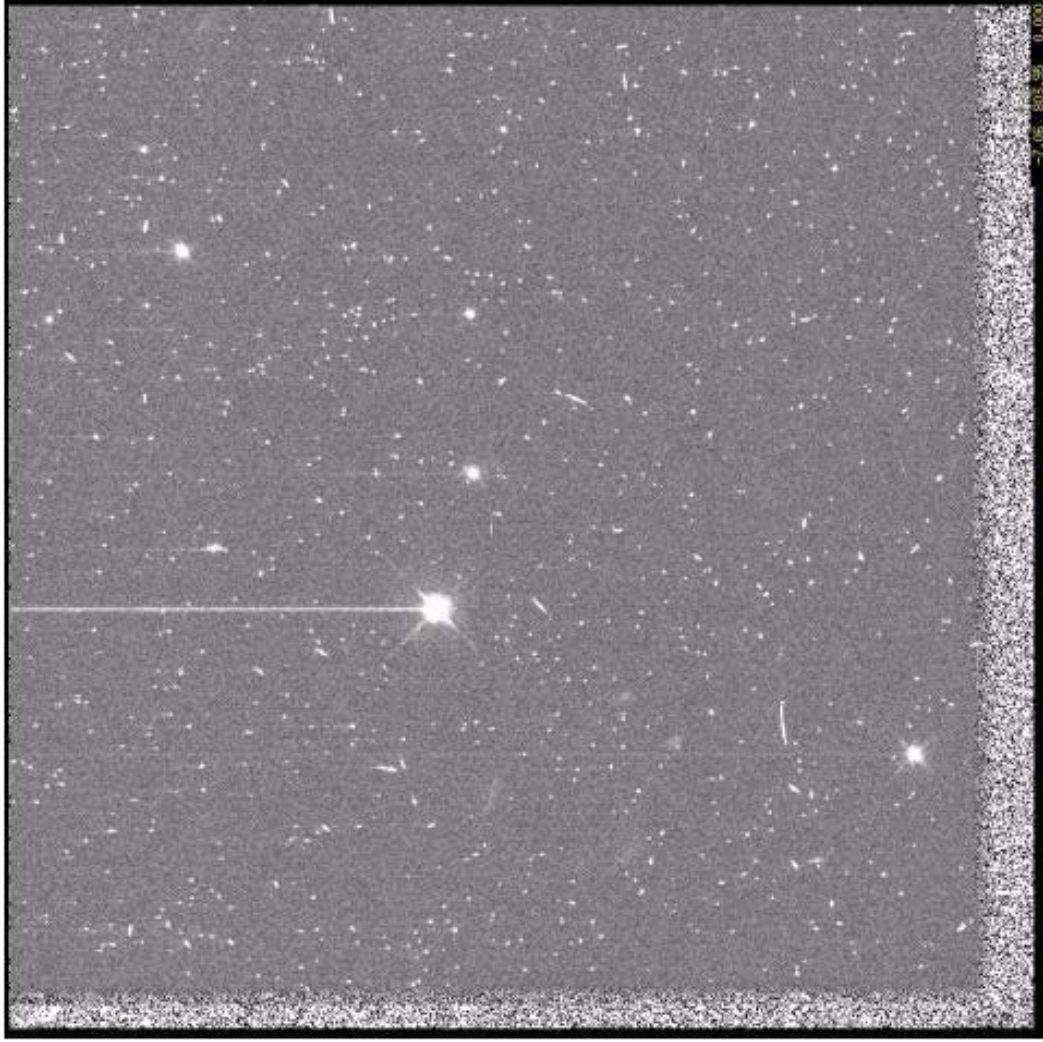
Secondary anomaly

- ◆ **Secondary anomaly on October 26:**
 - Usual anomaly followed by shutter open at end of exposure.
 - Interpreted as shutter bounce. Camera safed November 1.

**Shutter open at
readout causes trail
above each star**
