HST/GSFC Project Report

**Space Telescope
Users Committee
Meeting
May 12, 2016**

Gyro Elevated Motor Current Tiger Team

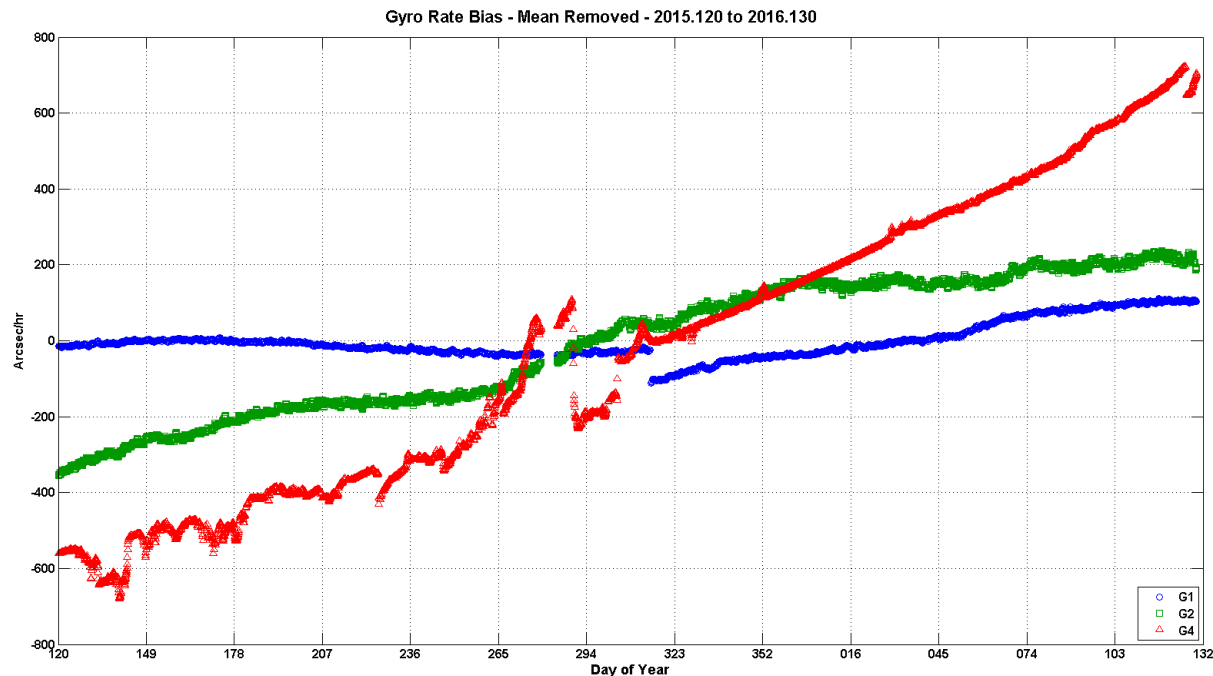
Mission Operations – Gyro Performance

- Gyro-4 performance had been out of family May-November 2015
- Gyros-1 and 2 each experienced a sudden increase in motor current in November
- Tiger Team investigated elevated motor current and provided initial briefing in February
- All 3 gyros have performed nominally in pointing control system since mid-November
- On May 5, Gyro-4 experienced a sudden bias shift that impacted 4 orbits

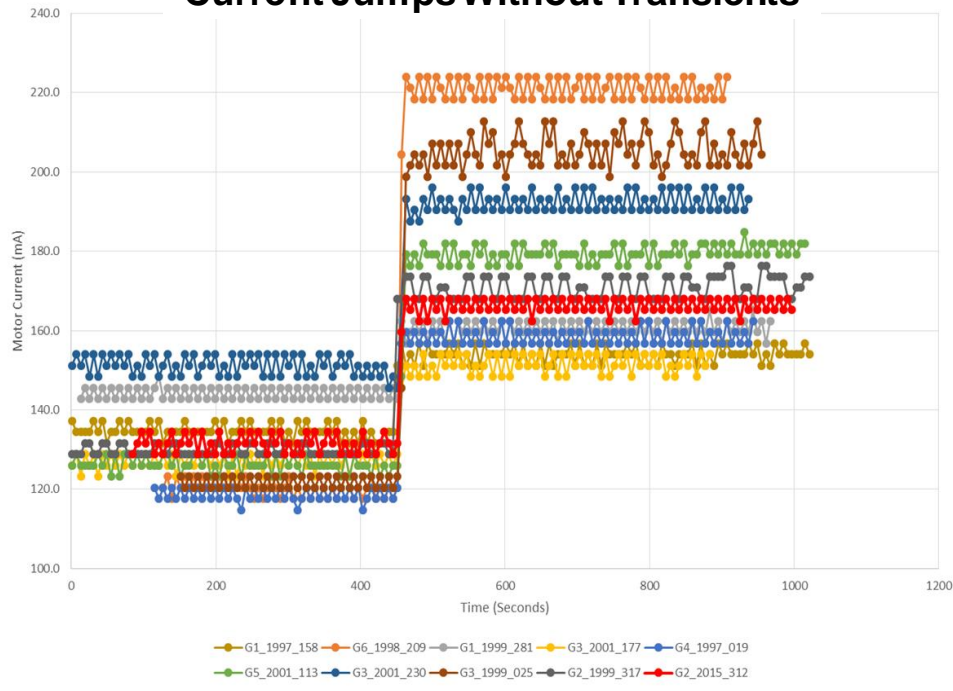
Minor-Step Motor Current Increase

Current Jumps Without Transients

Minor Step Signature

This type of Current Signature can be caused by:

1. **Flex Lead Failure:** A mechanical breakage of one of the motor's four flex leads resulting in close to doubling¹ of the motor current in the remaining operating phase. Since the breakage changes the force applied to the float, a Flex Lead Failure is usually associated with a large change in bias.

2. **Clock Discontinuity:** A momentary disruption of the drive clock resulting in a permanent² motor current increase due to exceeding the maximum operational phase angle between rotor and stator magnetic fields. Observed when the ECU's Channel clock master is changed.

3. **A Minor Rotor Restriction:** A permanent² increase in motor current initiated by a momentary restriction of the rotor caused by a particle(s) in the gap between the rotor and stationary motor components. The particles are passed through so fast that a transient is not observed in the motor current telemetry. This permanent² motor current increase is due to exceeding the maximum operational phase angle between rotor and stator magnetic fields (and potentially some small increased drag.) May result in small bias shift as a result of thermal transient caused by current increase.

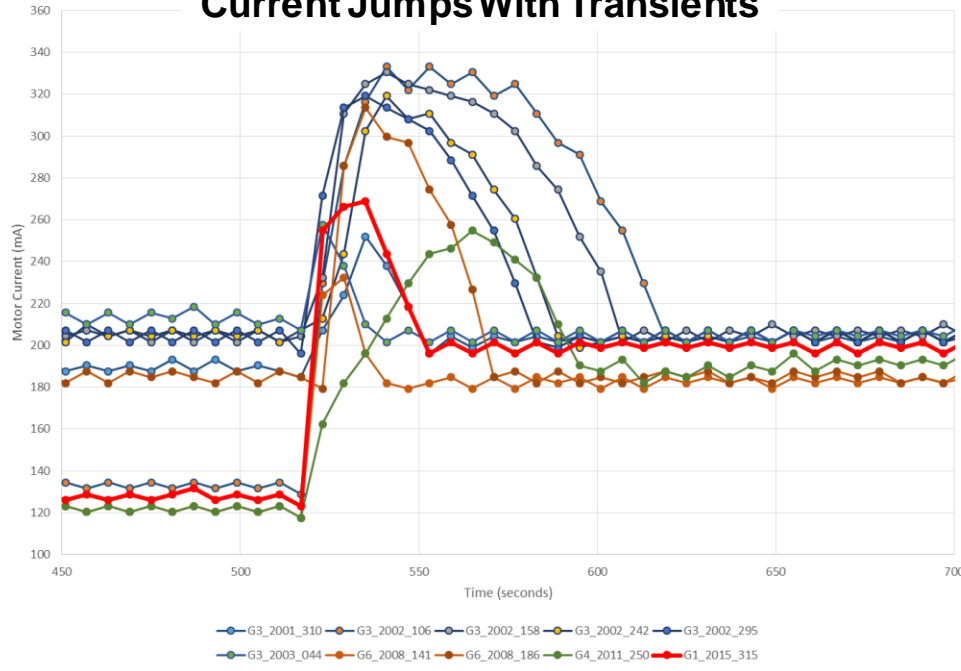
Major-Transient Step Motor Increase

Current Jumps With Transients

Major Transient Step Signature

This type of Current Signature can be caused by:

3. B. Major Transient Rotor Restriction:

A permanent² increase in motor current initiated by a restriction of the rotor caused by a particle(s) in the gap between the rotor and stationary motor components. The transient³ in motor current is the result of increased drag as the foreign particles is ground into smaller pieces (~100mA+ for <100 seconds). After the transient the increase in motor current is a combination of permanent² increase in motor current due to re-poling (weaker magnetization) and in some cases small increases in drag (~6mA) for an extended period (<year) as the smaller particles are redistributed. May result in small bias shift as a result of thermal transient caused by current increase.

2. Permanent until a restart of the motor at the higher start voltage provides maximal magnetization of the motor rotor. When exceeding the maximum operational phase angle, re-poling (weaker magnetization) of the rotor occurs, but at a weaker magnetization due to the running voltage being lower than the start voltage. Multiple rotor restrictions over time can result in multiple current steps, until a weakest rotor magnetization is reached.
3. During the transient, the increased current is the result of increased drag torque.
