James Webb Space Telescope Mission Status

Bill Ochs
JWST Project Manager
NASA GSFC

September 14, 2017

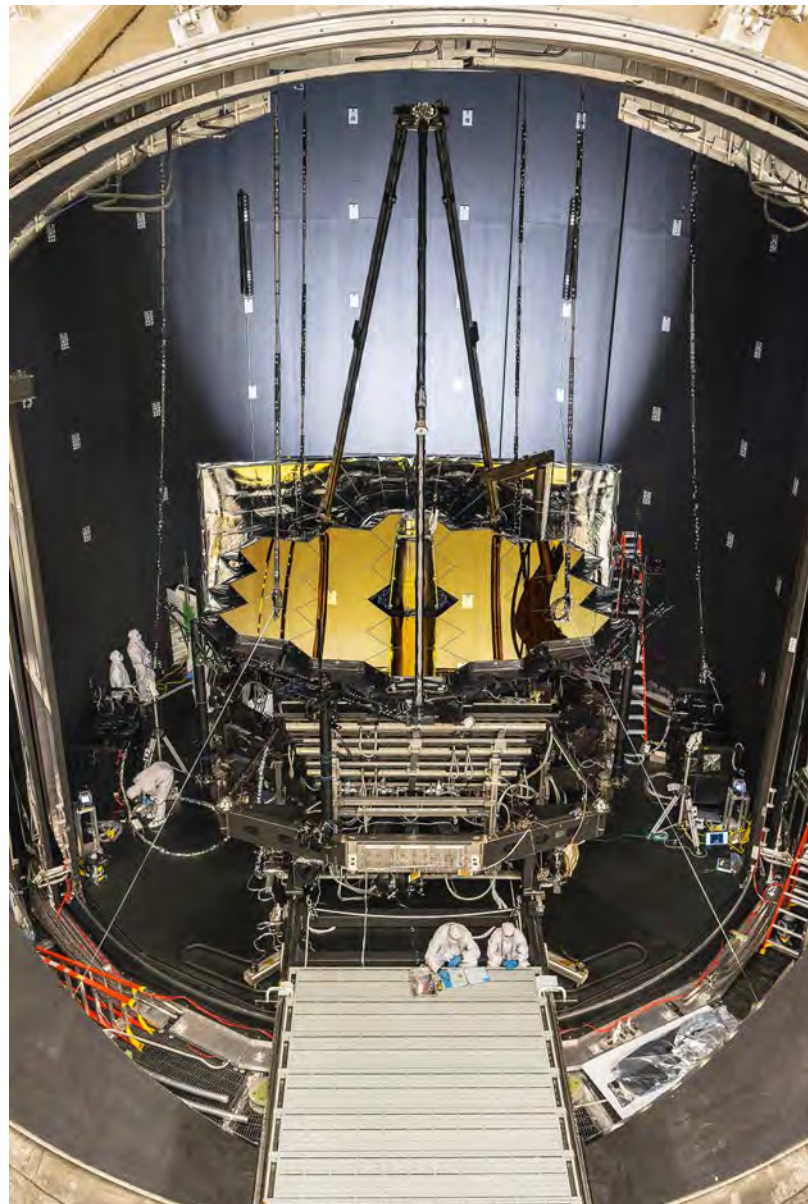
OTIS In Chamber A

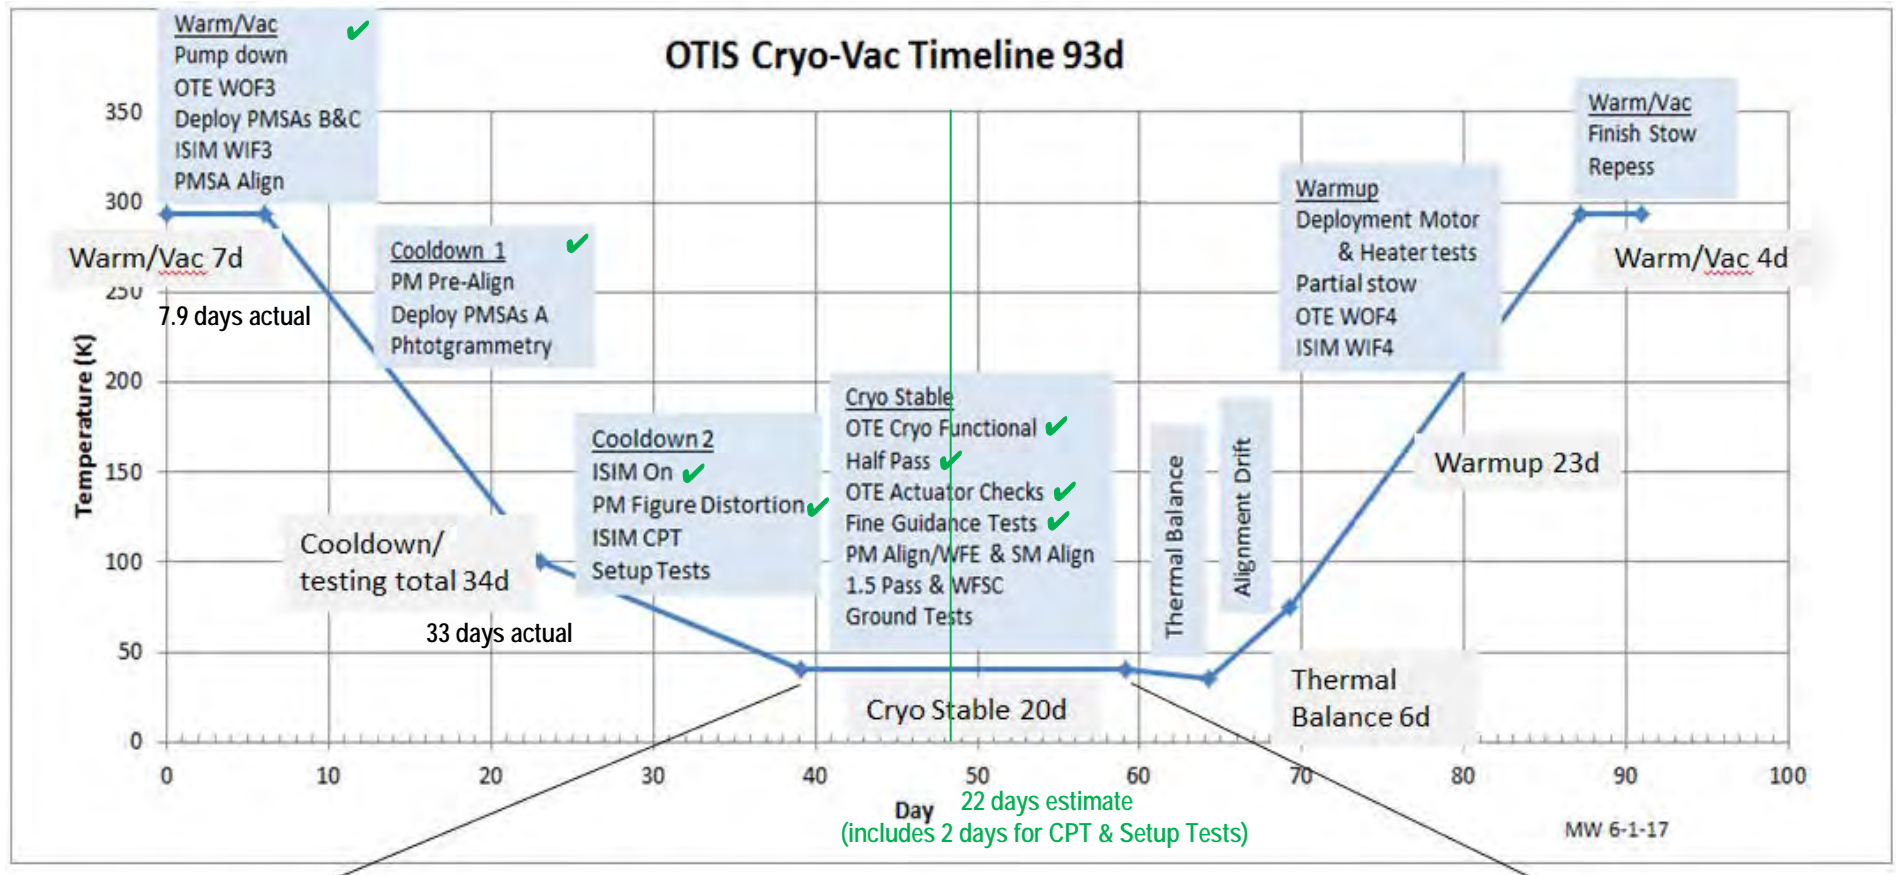
OTIS CV Test Timeline Summary

July 13th at 1:08 AM CDT - Test Start

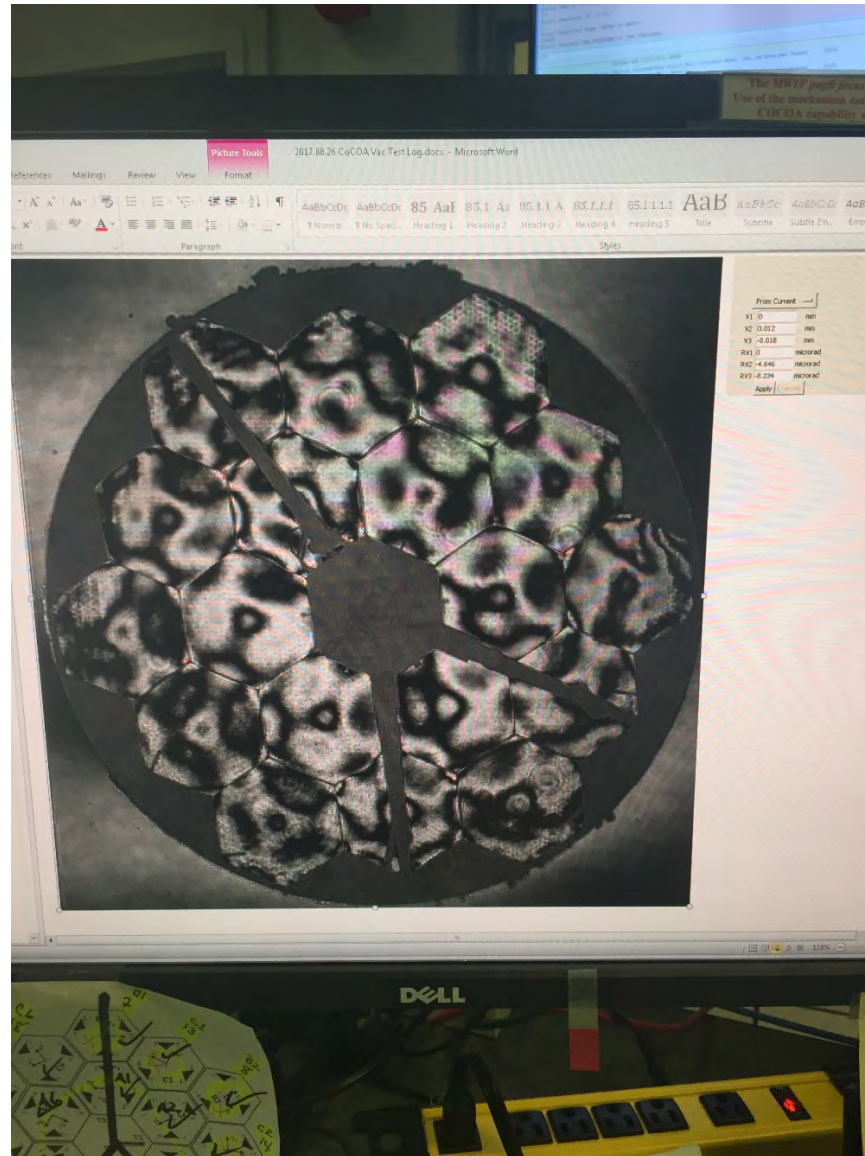
Primary Mirror Fringes Fully Aligned

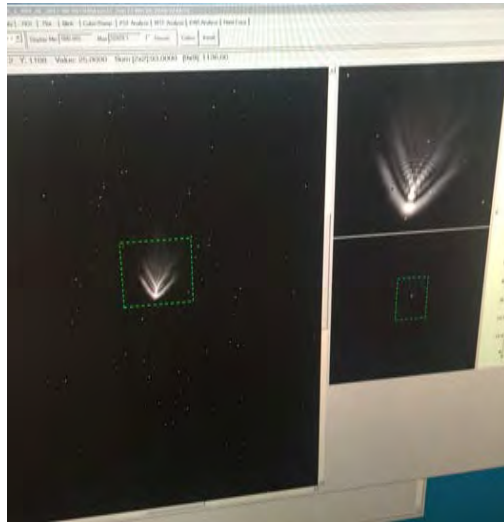
NIRCam

Instrument First Light

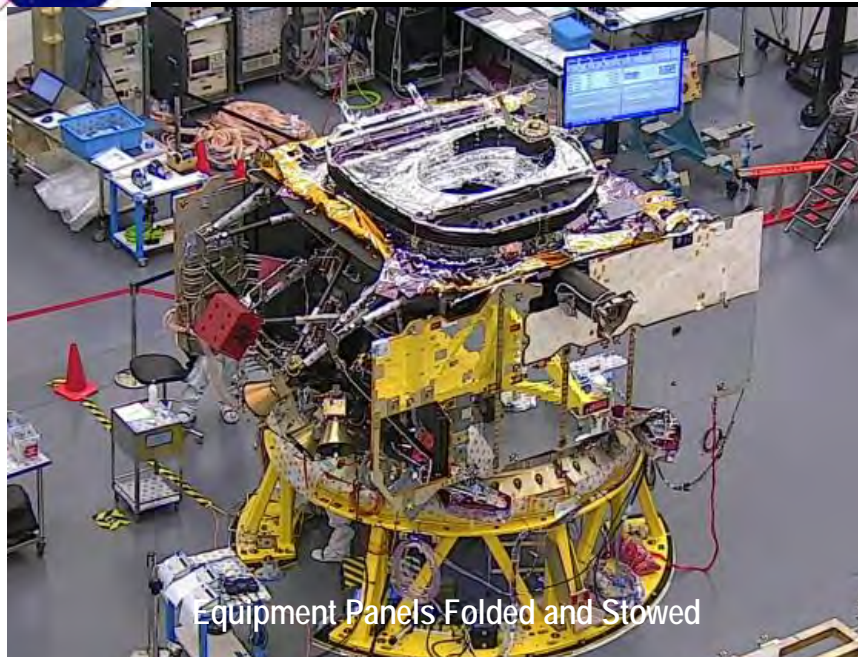
Equipment Panels Folded and Stowed

- Spacecraft electrical I&T complete and equipment panels closed.
- Comprehensive performance test (CST-1) successfully completed.
- EMI/EMC testing successfully completed
- Dual Thruster Modules (DTM) removed for valve replacement and DTM retrofit
- Next Steps (by end September)
 - Install Solar Array
 - Finalize DTM/Valve repair technique and installation schedule
 - Finalize DTM verification plans

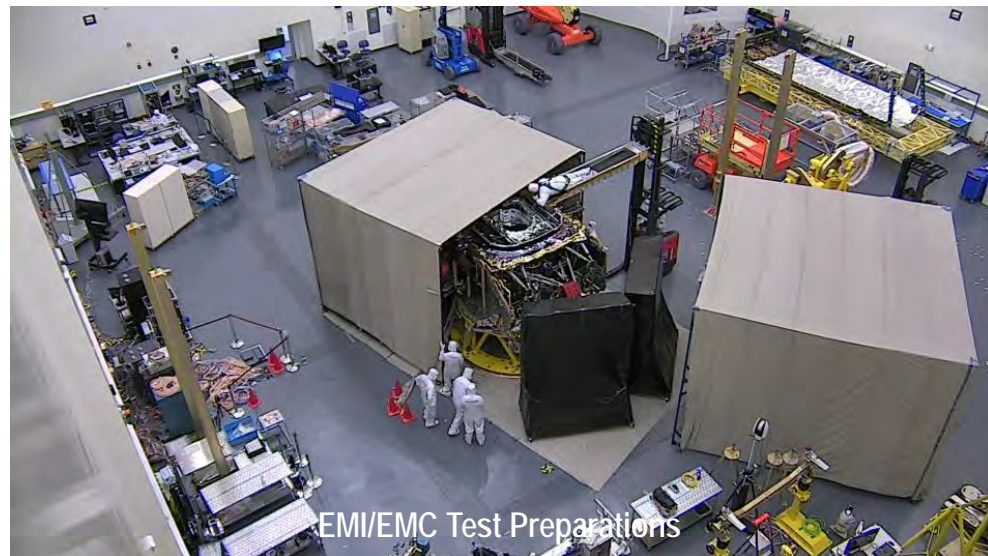
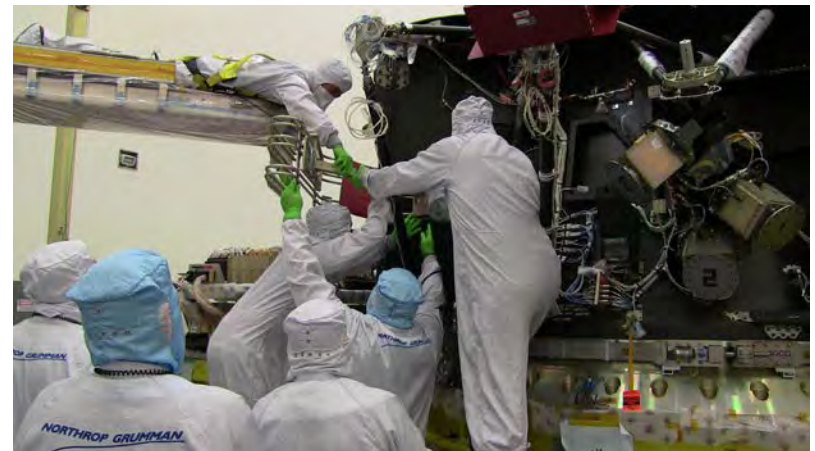
EMI/EMC Test Preparations

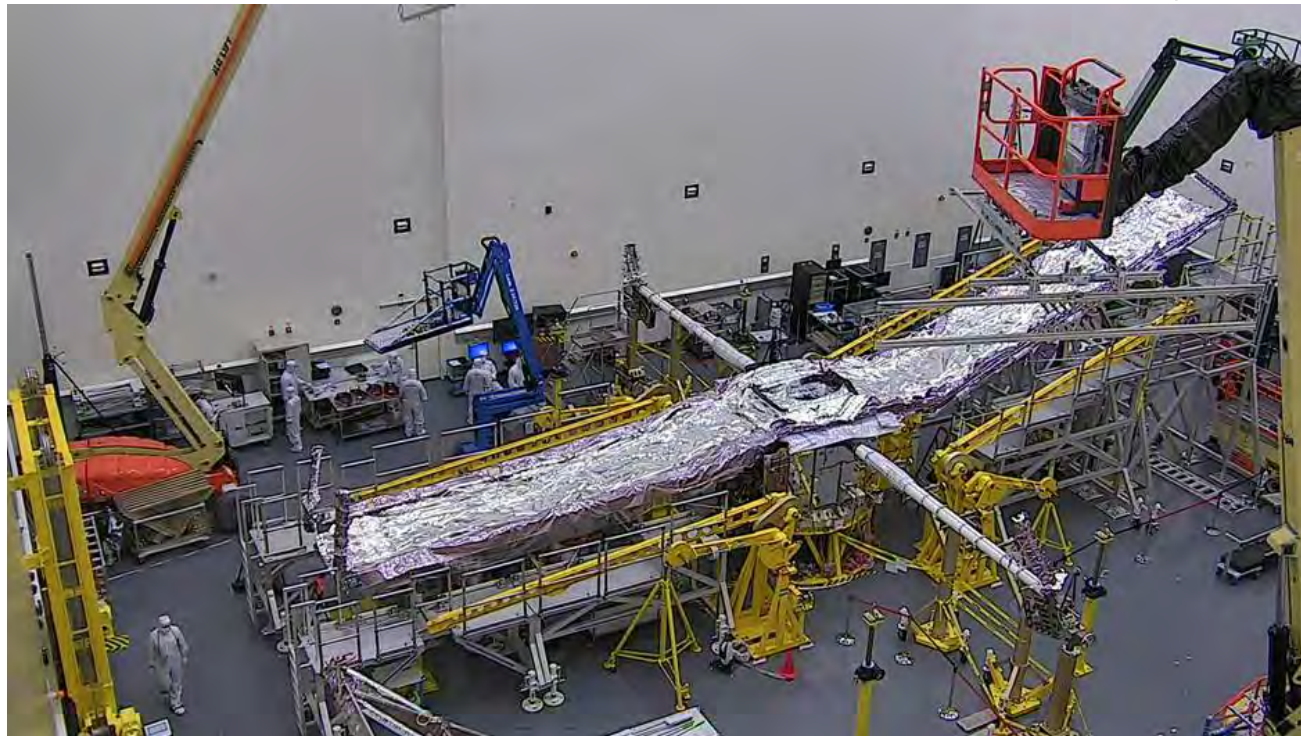
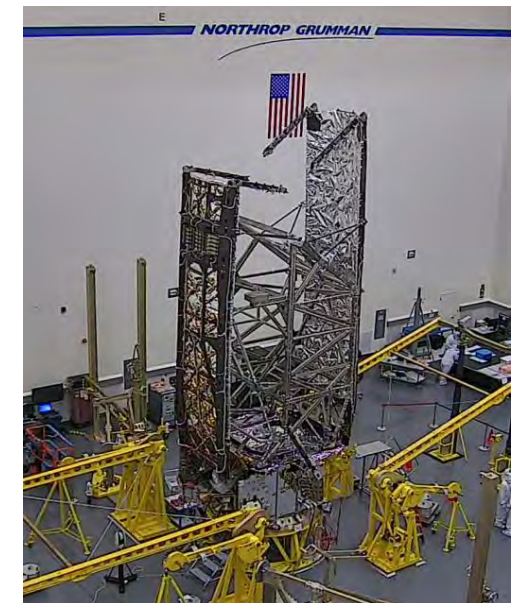
All Sunshield hardware has been delivered with nearly complete integration

Skeleton level folding and deployment complete

- All primary structure installed and functionally tested
- Membranes installed and folded
- Cover installation and Membrane Release Devices (MRDs) installation underway
- Next Steps (by end of September)
 - Support final stowage and pre-environmental deployment
 - Support install of DRSA-H

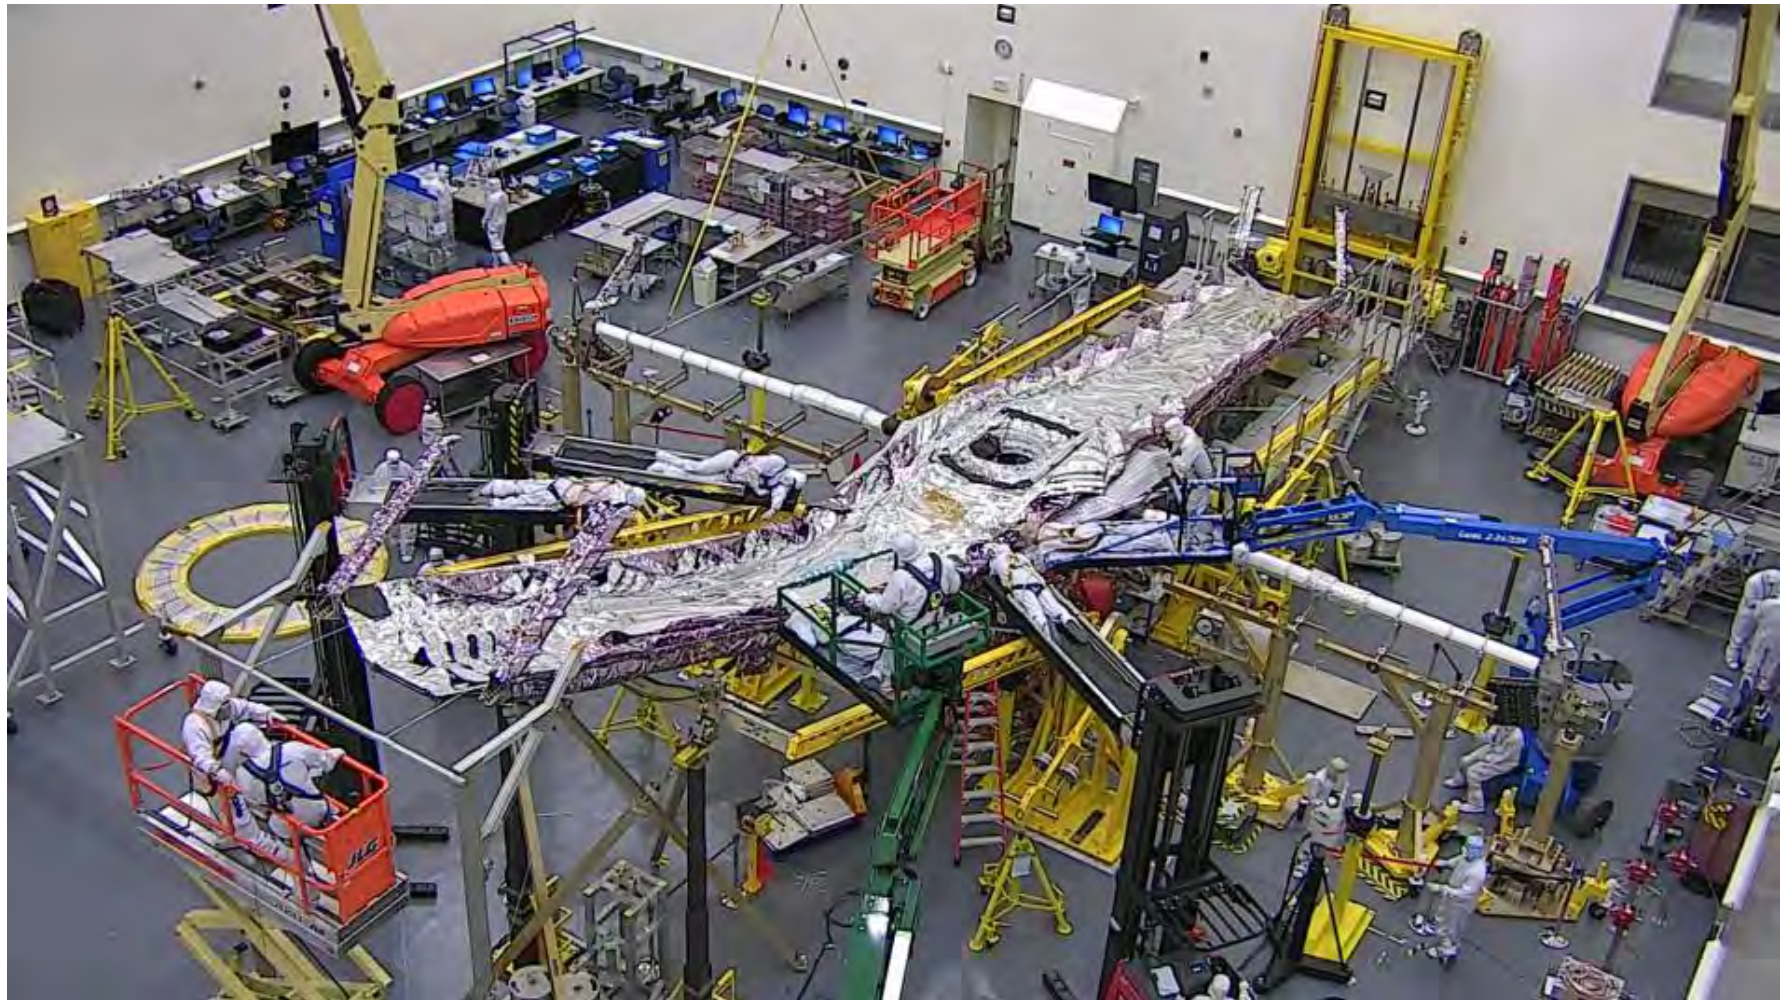
Sunshield Membrane Release Device Installation

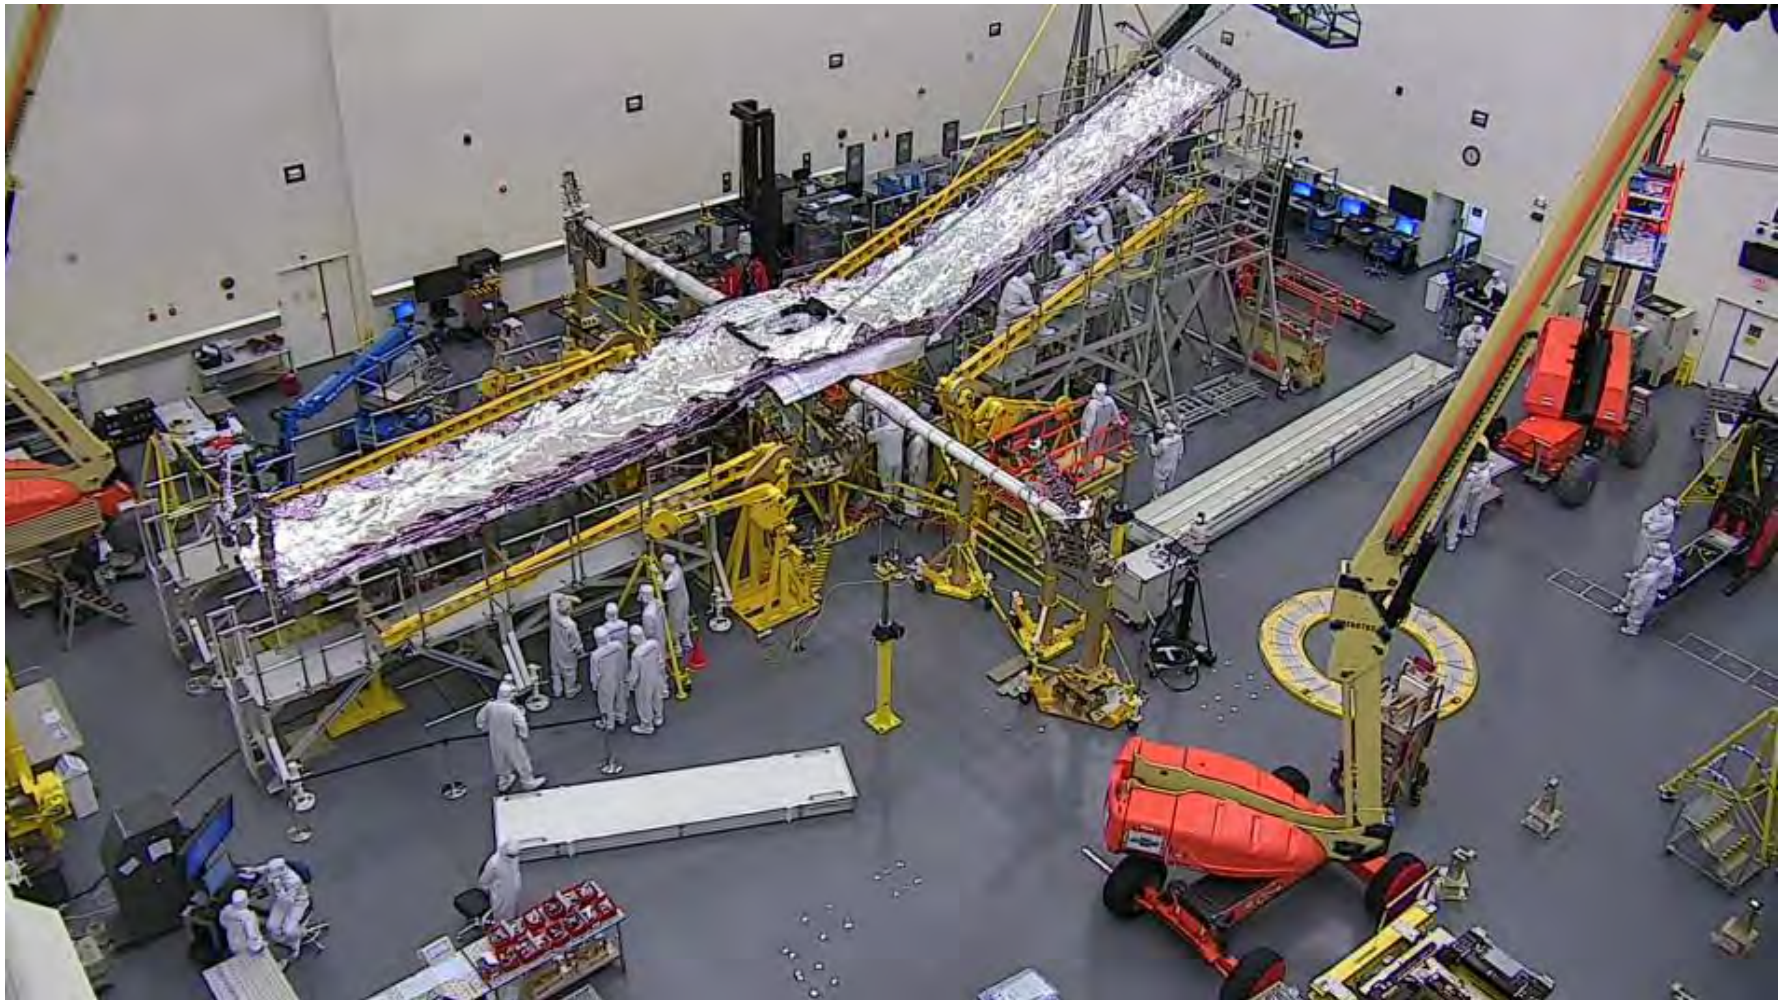
Sunshield Membrane Release Device Installation

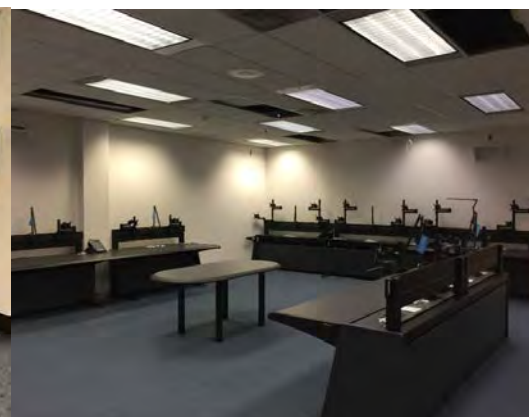
Successful GSEG-1 utilized SN antenna (left), DSN test trailer and dedicated personnel (right)

- Utilized TDRS (via SN antenna at NGAS) and DSN (via the DSN Test Trailer); both SN and DSN were able to verify compatibility with JWST at all rates/configurations
