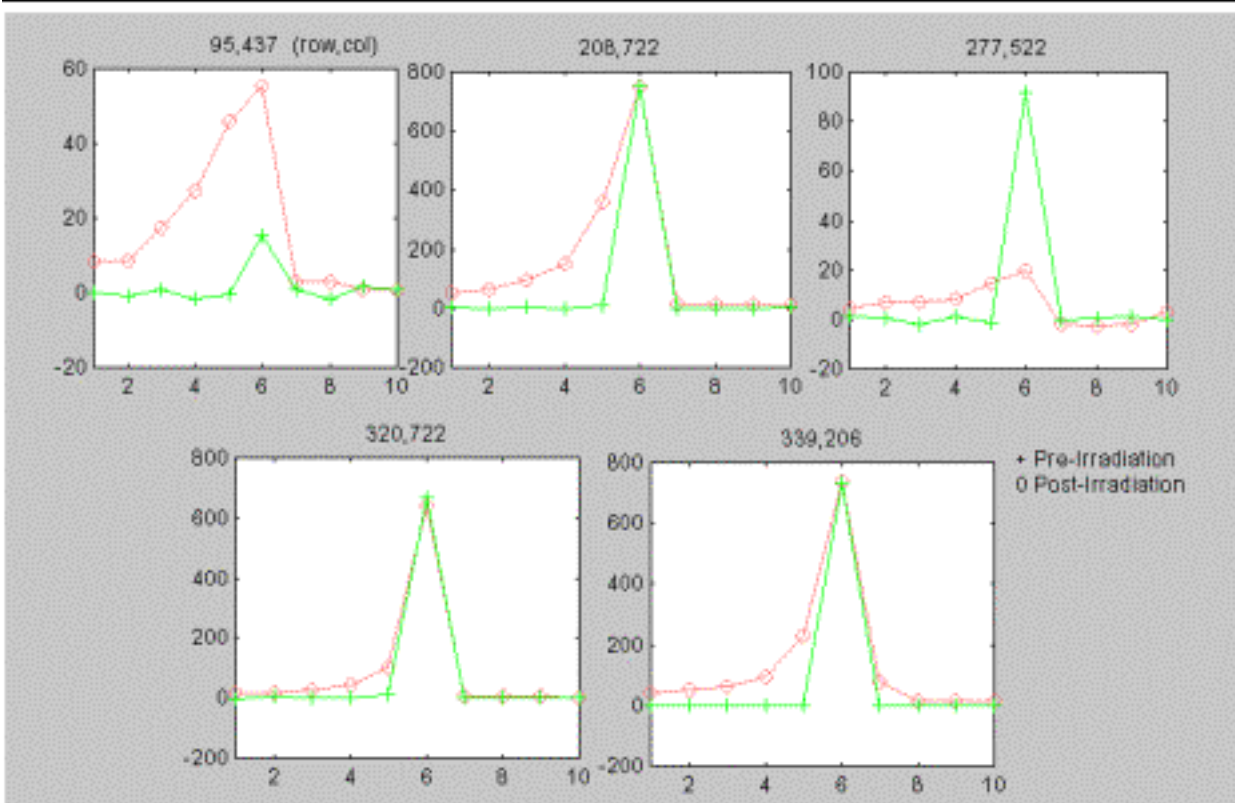
Figure 1 Example of Vertical Traces Around Defect Pixels Before and After Irradiation. Background Subtracted using 1-D Highpass Butterworth Filter in Horizontal
